TESTING & INSPECTION REPORT

Client ELLEN NEVINS Date 8-2-04
 Project Name 1 SILVERTHORNE LANE Architect —
 Project Address BELLE MEAD, NEW JERSEY Construction Mgr. —
 Project Address _____ Engineer A.E.T.
 Contractor TOLL BROTHERS Project # R400119

REF: Ellen Nevins v. Toll Bros. et al. – Supplemental Report

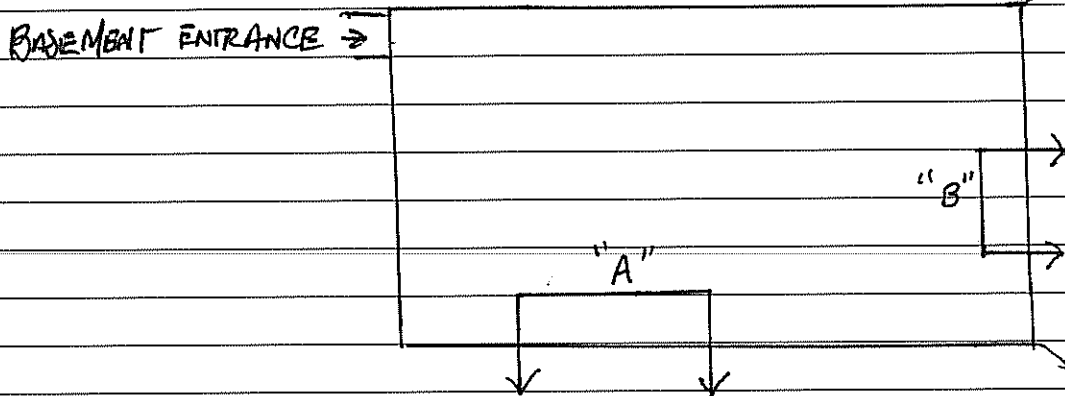
REAR

Remarks: REPORTED TO THE ABOVE PROJECT TO MONITOR A.E.T. (APPLIED ENGINEERING TECHNOLOGY) AS THEY PERFORMED REINFORCING STEEL DETECTION IN THE BASEMENT CONCRETE WALLS OF THE ABOVE RESIDENCE (2) WALLS WERE SCANNED UTILIZING A HILTI FS 10 FERROSCAN INSTRUMENT. REINFORCING WAS DETECTED AS SHOWN (ATTACHED)

ONLY (2) WALLS WERE SCANNED THIS DATE
NO VERTICAL REINFORCING WAS FOUND.
CONCRETE WALLS MEASURED 8" IN THICKNESS
