TESTING & INSPECTION REPORT

Client ELEN NEVINS Date 8-2-04
 Project Name 1 SILVERTHORNE LANE Architect ---
 Project Address BELLE MEAD, NEW JERSEY Construction Mgr. ---
 Project Address _____ Engineer A.E.T.
 Contractor TOLL BROTHERS Project # _____

INSPECTION REPORT

Project Name (per plans) 1 SILVERTHORN LANE BELLE MEAD

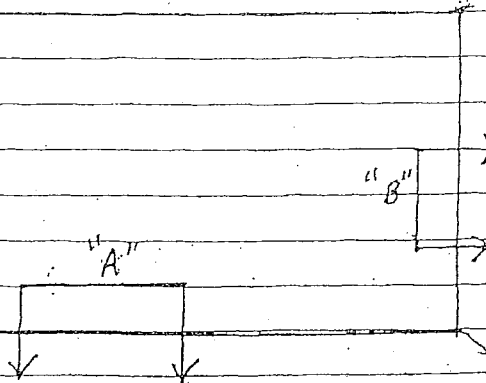
Remarks: REPORTED TO THE ABOVE PROJECT TO MONITOR A.E.T. (APPLIED ENGINEERING TECHNOLOGY) AS THEY PERFORMED REINFORCING STEEL DETECTION IN THE BASEMENT CONCRETE WALLS OF THE ABOVE RESIDENCE. (2) WALLS WERE SCANNED UTILIZING A HILTI FS 16 FERROSCAN INSTRUMENT. REINFORCING WAS DETECTED AS SHOWN (ATTACHED)

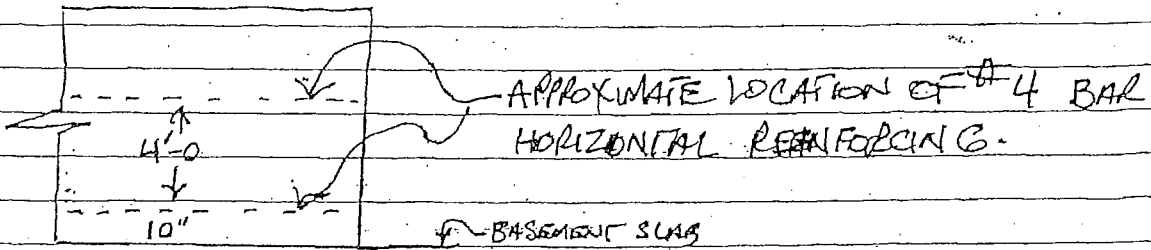
SECTION "A" + "B"
(NTS)

ONLY (2) WALLS WERE SCANNED THIS DATE
NO VERTICAL REINFORCING WAS FOUND
CONCRETE WALLS MEASURED 8" IN THICKNESS
